ENGINEERING CASE LIBRARYFRACTURE MECHANICS AND HELICOPTER FAILURE

This Case was prepared by Diane Rocheleau under the direction of Professor G. Kardos as an Independent Study at Carleton University.

## FRACTURE MECHANICS AND HELICOPTER FAILURE

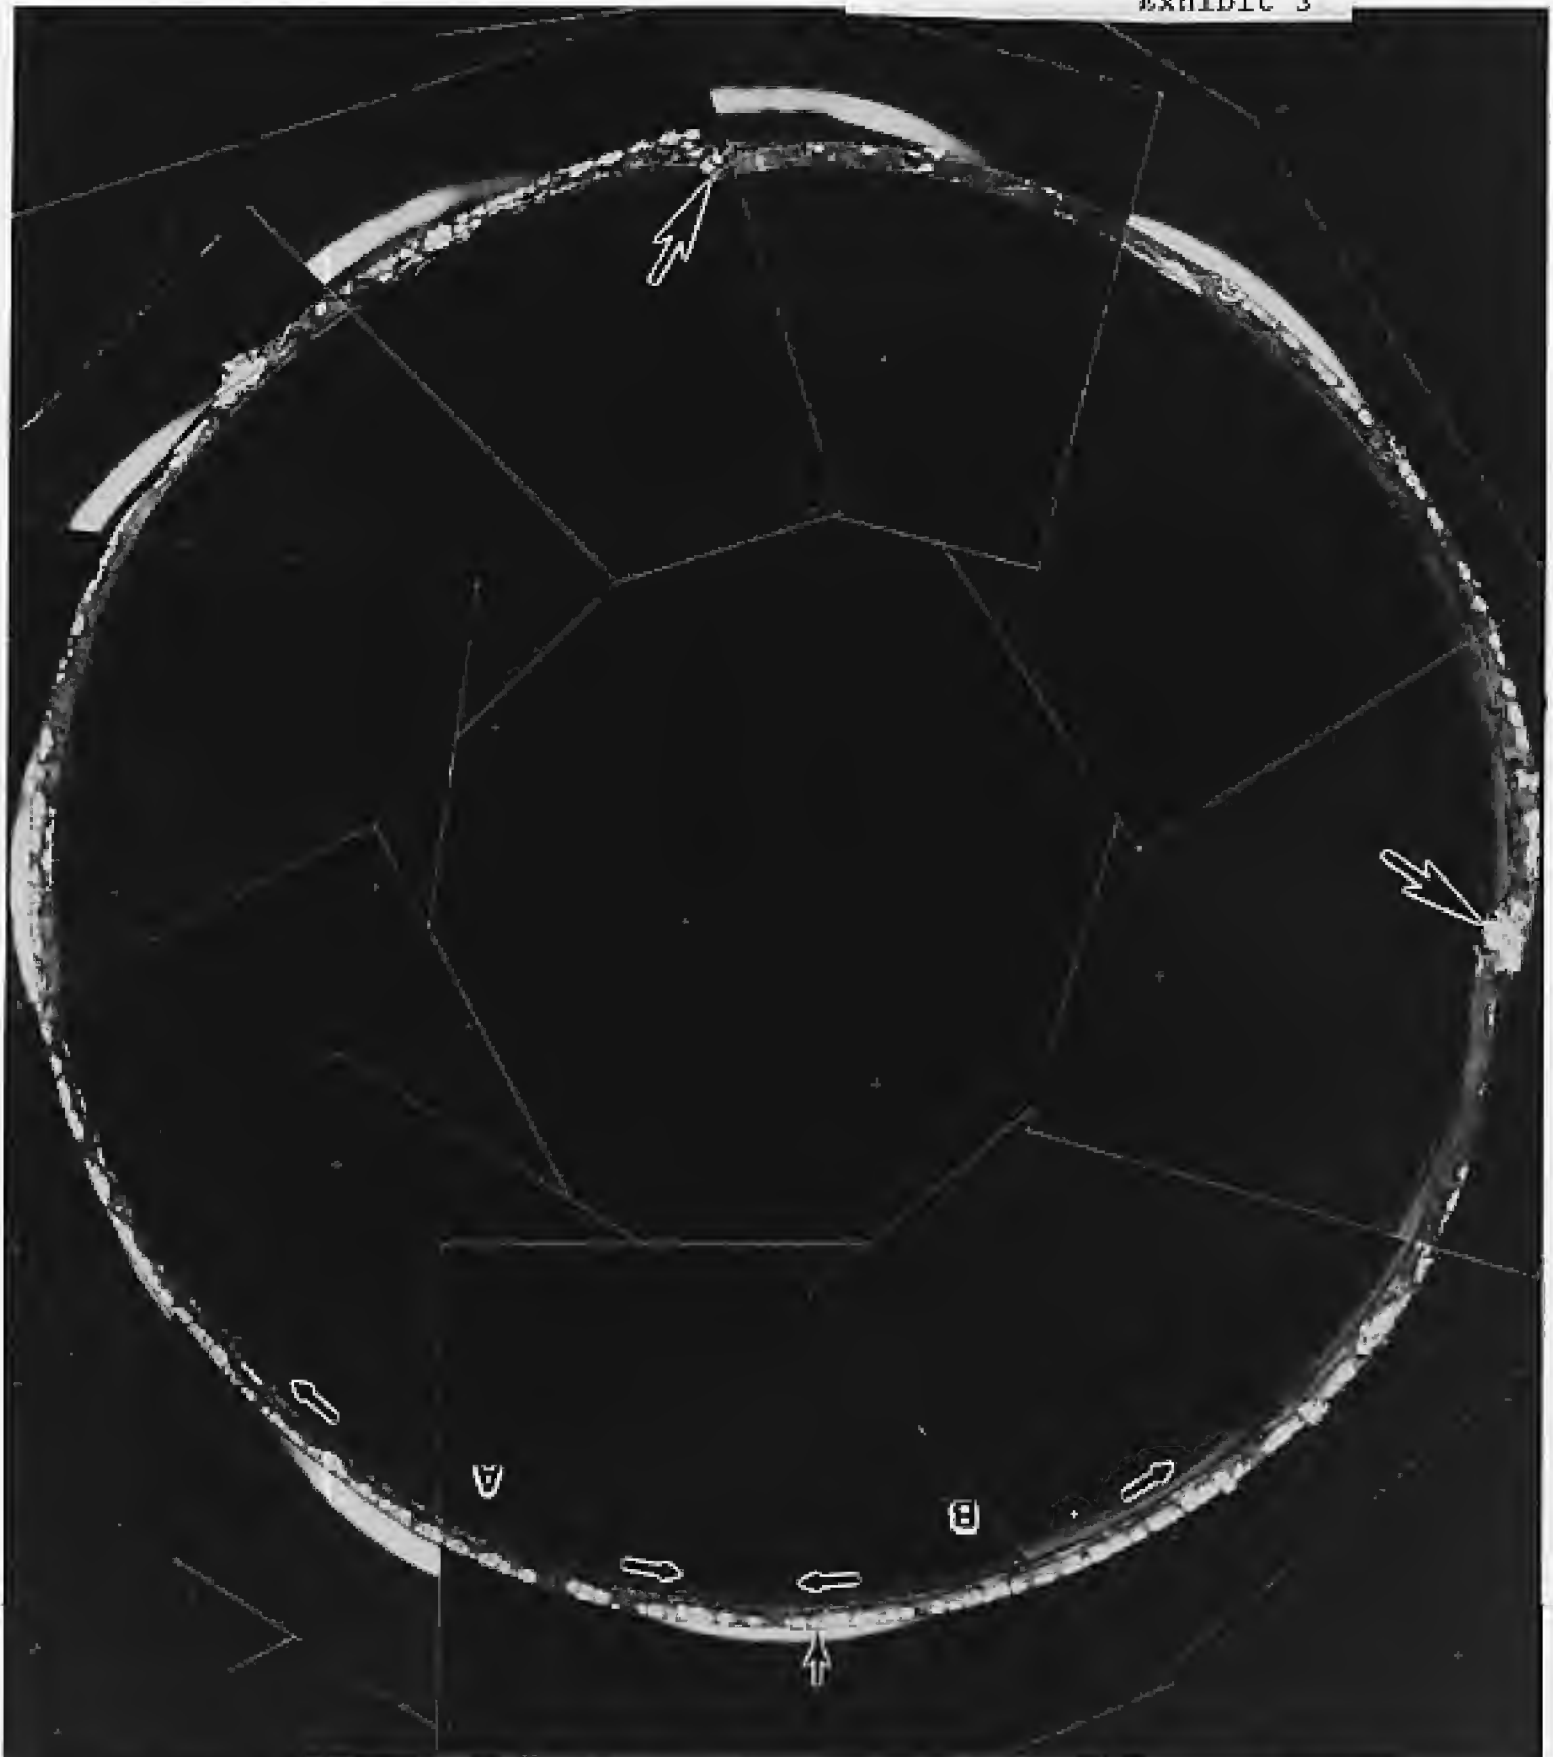
I examined the fracture in the microscope; there were over 200 fisheye precracks along the outer circumference of the sleeve. Fatigue could be seen starting from some of those precracks. The precracks had a shiny appearance, typical of an intergranular mode of failure, and consistent with a hydrogen assisted failure (Exhibit 3).

The precracks were in the form of fisheyes which started either at or near the outer surface of the collective sleeve tube. The fisheyes penetrated up to 77 percent of the total thickness of the sleeve wall and were in a continuous pattern around the tube circumference, except for two fisheye-free zones, each approximately 3.1 inches in length (Exhibit 3). The wall thickness at the fracture location was 0.068 inch, and the outer diameter of the sleeve was 4.529 inches. From this, we established that the total precracked area was approximately 28 percent of the total load bearing area. The fatigue growth from the fisheyes was small, approximately one percent.

EXHIBIT 3 - MONTAGE OF THE FRACTURE SURFACE ON THE SLEEVE SHOWING THE HYDROGEN EMBRITTLEMENT PRECRACKS (FISHEYES). ARROWS POINT TO AREAS OF INTEREST.

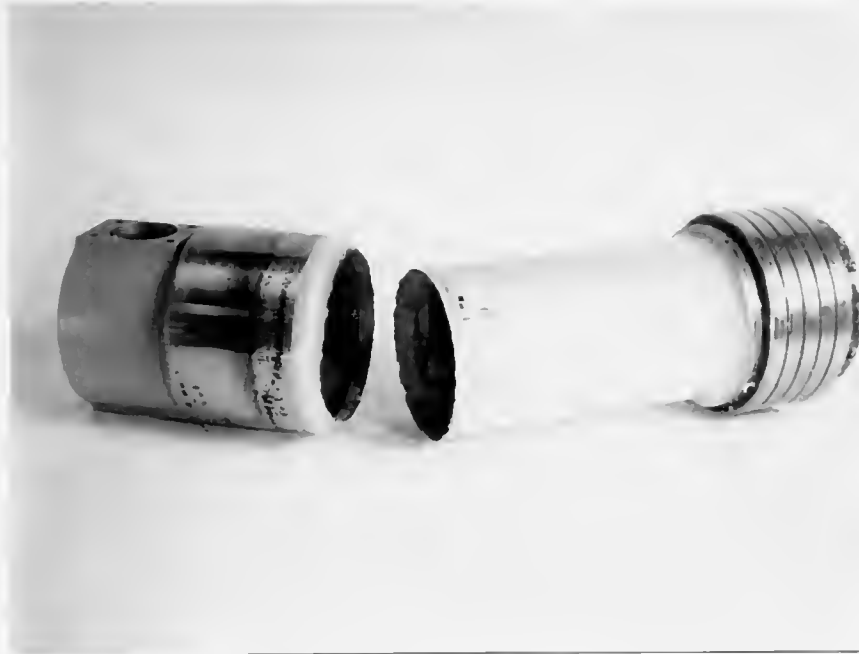
Additional factors had to be considered to determine the actual stress. The fracture occurred in a fillet, at a change of cross-section (Exhibits 8 and 9). The stress concentration factor was taken from a Machine Design textbook (Exhibit 10). The sleeve was precracked approximately 28 percent of the total load bearing area, increasing the stress at that location.

EXHIBIT 8 - COLLECTIVE SLEEVE AS-RECEIVED. THE FRACTURE IS IN THE FILLET AREA. MAGNIFICATION APPROXIMATELY 0.2 TIMES.

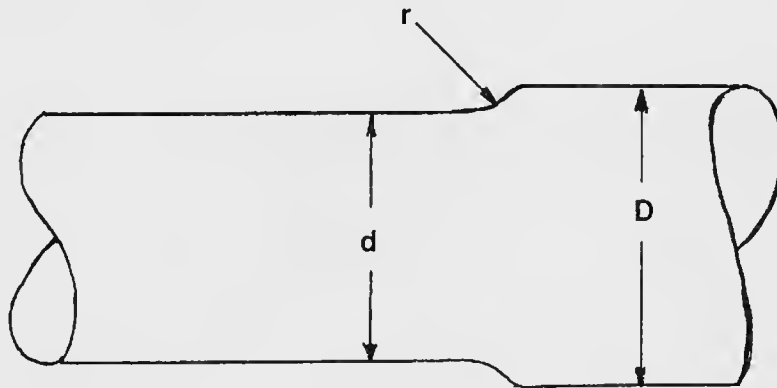
D = 5.12 inches  
d = 4.5 inches  
r = 0.5 inches

EXHIBIT 9 - SCHEMATIC OF THE COLLECTIVE SLEEVE CROSS-SECTION INDICATING THE ACTUAL DIMENSIONS. THE FRACTURE IS AT LOCATION "r".

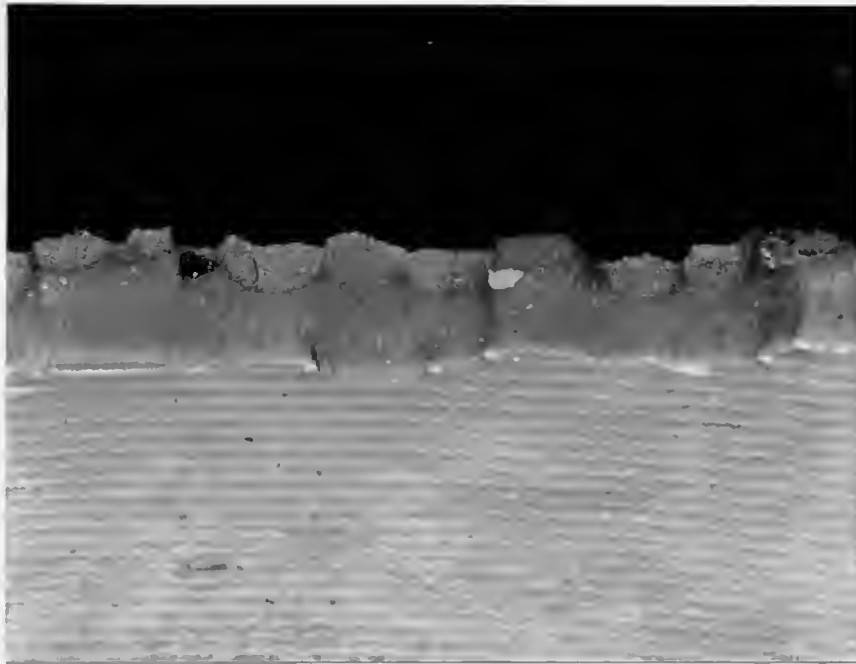
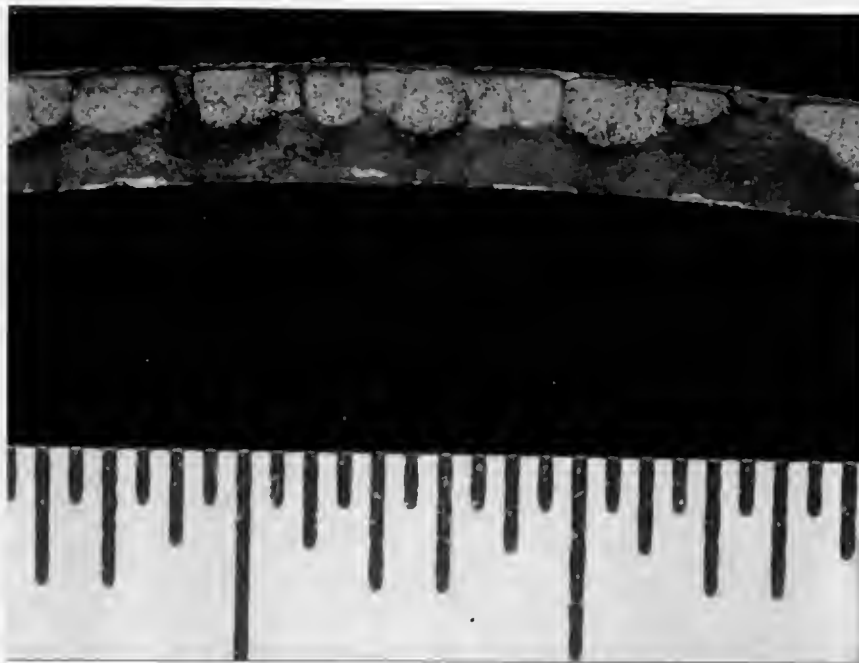
The fracture toughness could not be calculated directly from the plastic zone size on our sleeve, as the fracture features were almost 100% slant/shear type (Exhibit 11), typical of 100% plane stress conditions, and therefore, flat areas from which I could have extracted the plastic zone size "r" were almost non existent.

What were the flaw parameters ? This was not just a single crack, but rather a string of cracks, although they were not all on the same plane (Exhibit 11). The deepest crack observed around the fracture surface was 0.0525 inches, which I took as "a". I considered four possible values for the crack width "2c":

EXHIBIT 11 - CLOSE-UP OF SOME OF THE FISHEYE CRACKS. THE TOP VIEW SHOWS THE 45° SLANT OF THE FRACTURE SURFACE, AND THE DIFFERENT PLANES ON WHICH THE FISHEYES ARE LOCATED. THE BOTTOM VIEW SHOWS HOW SOME OF THE FISHEYES COLLECT IN CLUSTERS.

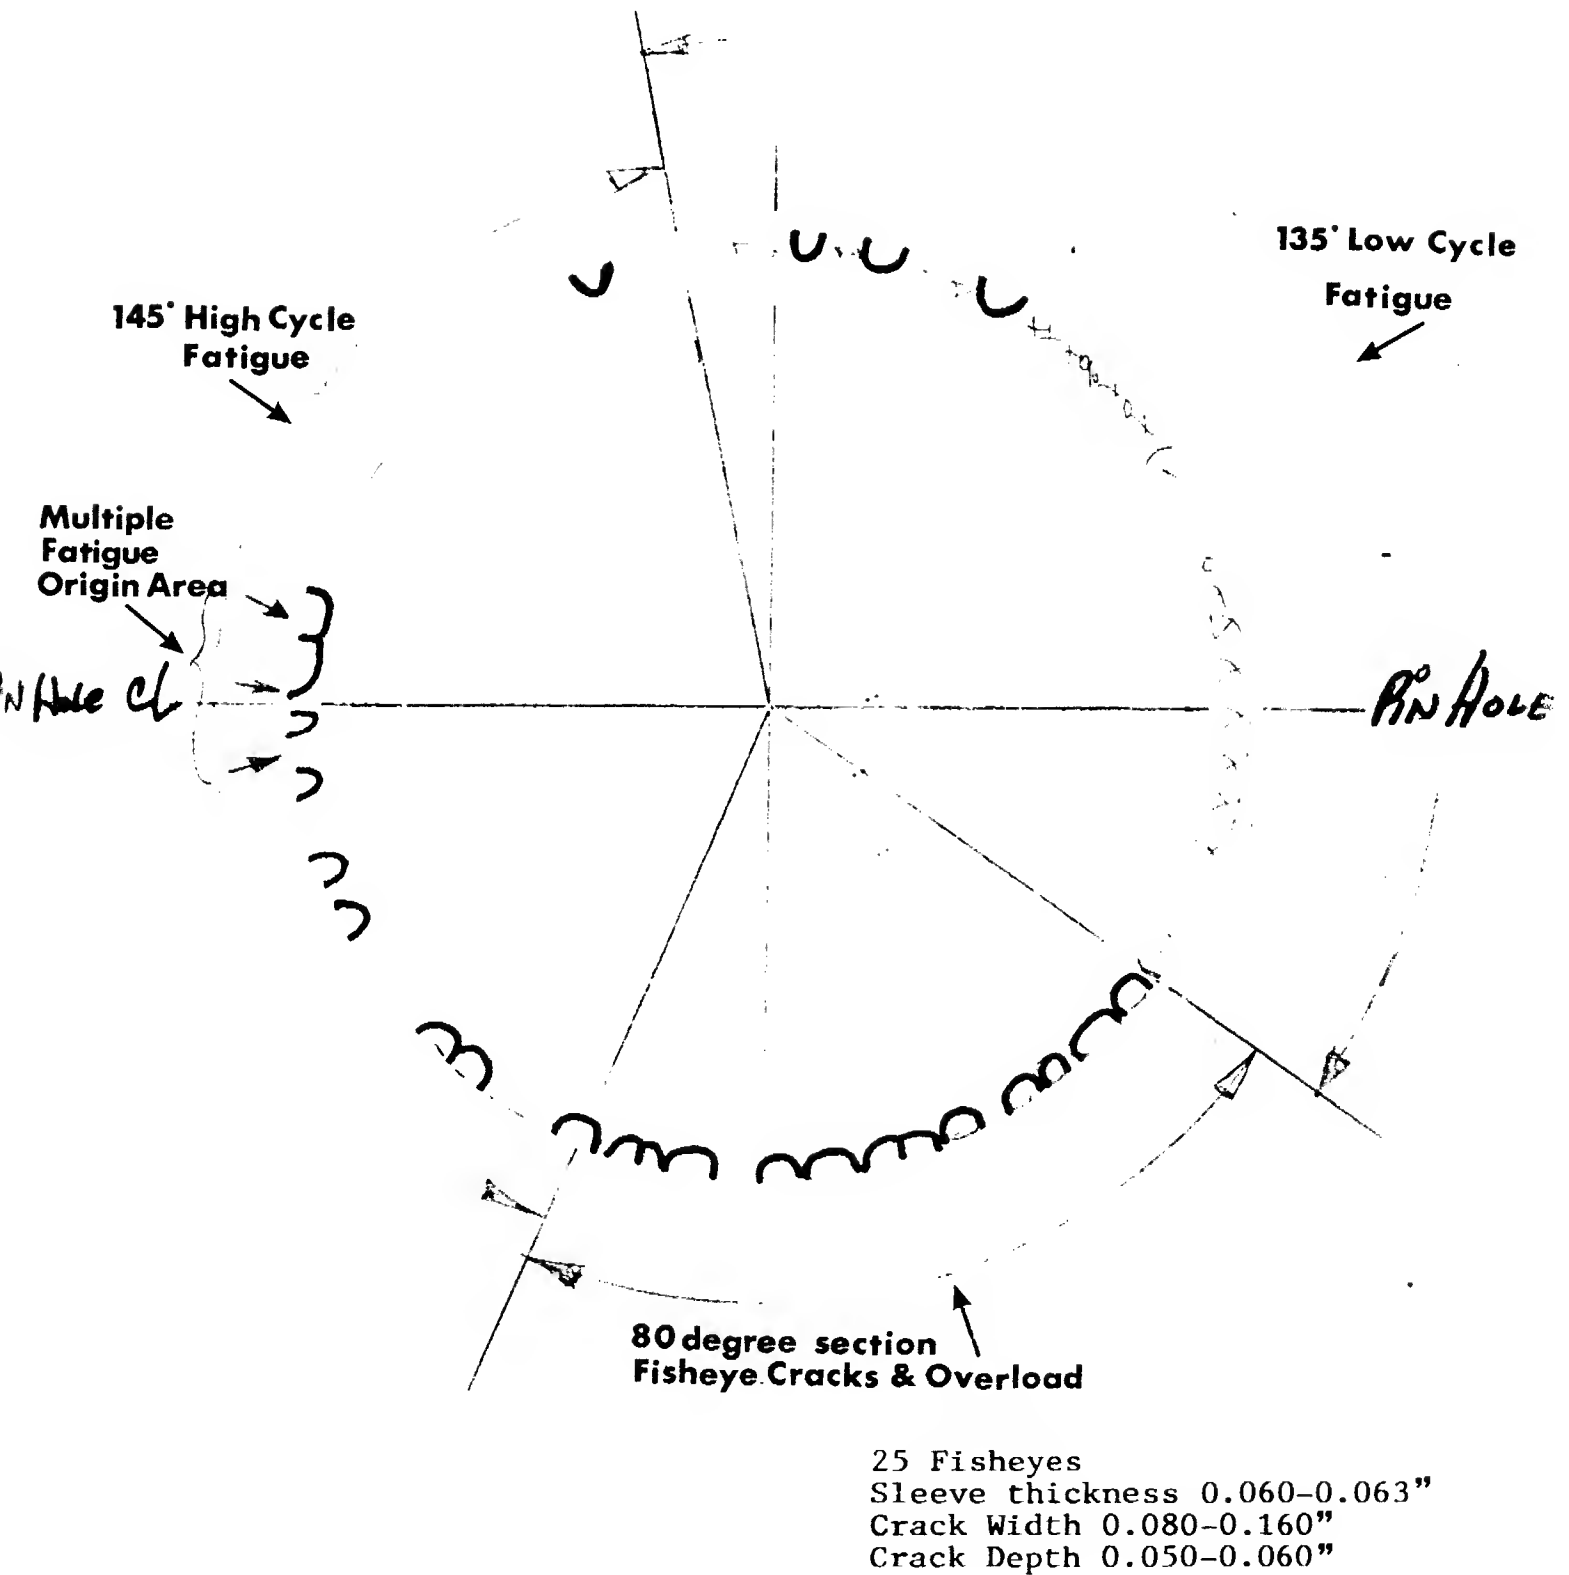
EXHIBIT 15

To verify how accurate the fracture toughness values of 80 and 175 ksi  $\sqrt{\text{inch}}$  were, I could use the data from the Osmian sleeve failure. The only details available to us on this failure were those written on the sketch sent to us by BHT (Exhibit 15). No other information such as the appearance of the fracture surface was available. I assumed that Cruise flight loads were applied to the sleeve and that the sleeve failed at the fillet radius approximately the same location as the Edmonton helicopter.

Only about 80 degrees of the sleeve was intact, the remainder was cracked completely through the thickness. Fisheyes were present on the remaining 80 degrees. Precise information about the depth, width and area of the fisheyes was not available. However, the figures marked on the sketch indicated that there were 12.5 fisheyes in the section still holding, the crack depths varied from 0.050 to 0.060 inches, and the crack widths from 0.080 to 0.160 inches.

VIEW LOOKING DOWN AT THE FRACTURE, ON LOWER END OF THE COLLECTIVE SLEEVE
